ENVIRONMENTAL, SAFETY & HEALTH MANAGEMENT DURING CONSTRUCTION OF PILED ROAD STRUCTURES ON EXISTING LANDFILL SITE

**Koh Hwee Ying, Kuek Chin Meng,
Tan Peng Heng, Lau Hwa Cheong, Yap Cheng Chwee**
*Road Projects Group
Land Transport Authority, Singapore
No. 1 Hampshire Road, Singapore 219428
hwee_ying_koh@lta.gov.sg, chin_meng_kuek@lta.gov.sg,
peng_heng_tan@lta.gov.sg, hwa_cheong_lau@lta.gov.sg,
cheng_chwee_yap@lta.gov.sg*

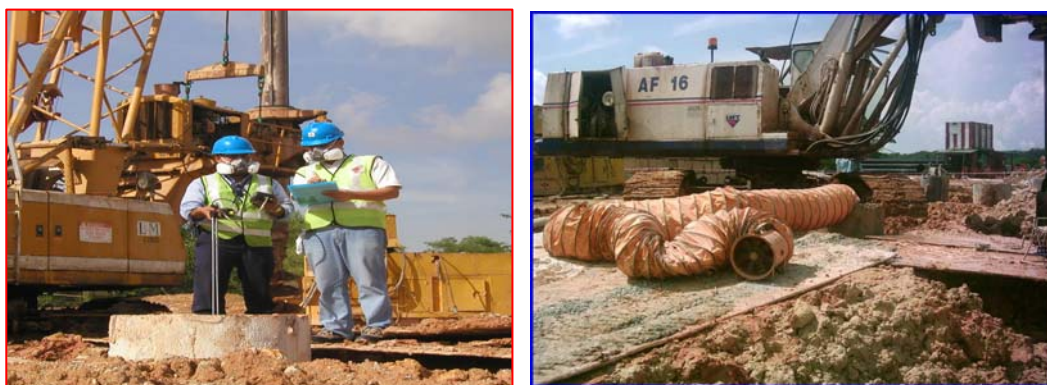
Figure 6.1 Landfill gas measurement and forced ventilation with air blower during bored piling work

Parameter	Measurement	Action required
Methane	>10% of Lower Explosive Limit (LEL)	Prohibit hot works Ventilate to restore methane to < 10% LEL (Figure 6.1)
	>20% LEL	Stop works Evacuate all working personnel / prohibit entry Ventilate to restore methane to < 10% LEL
Oxygen	<19%	Ventilate trench to restore oxygen to >19%
	<18%	Stop works Evacuate personnel / prohibit entry Increase ventilation to restore oxygen to >19%
Carbon Dioxide	>0.5%	Ventilate trench to restore carbon dioxide to <0.5%
	>1.5%	Stop works Evacuate personnel/ prohibit entry Ventilate to restore methane to <10% LEL and carbon dioxide to <0.5%

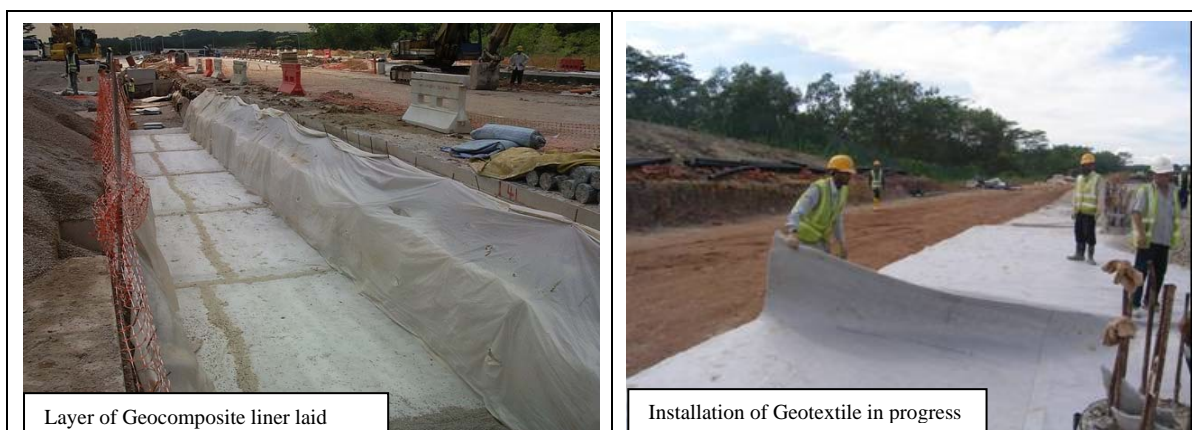
Figure 8 Installation of landfill capping system

On the installation of landfill capping and gas venting system, the risk due to landfill related hazards was relatively lesser as the excavation work was kept within the original soil capping to landfill in an open air environment (Figures 8 & 9).

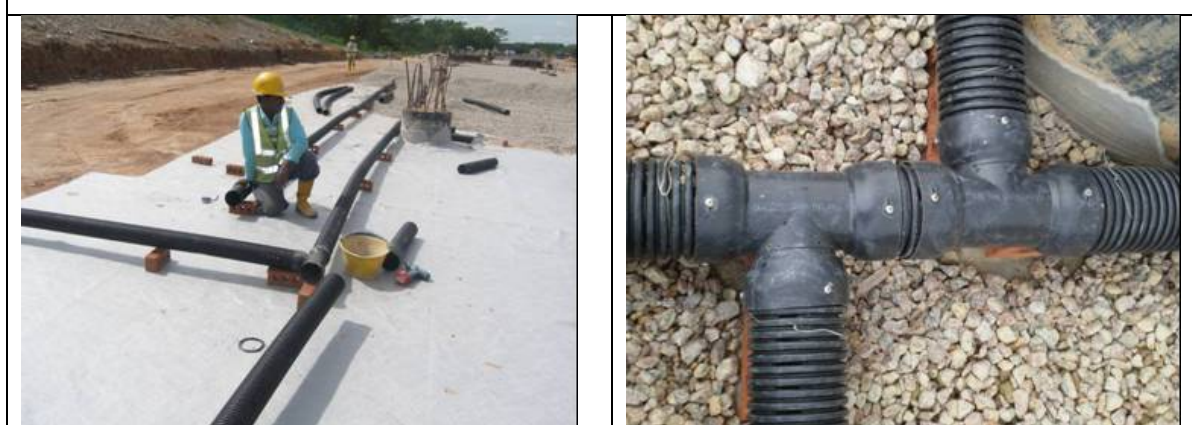
Figure 9 Installation of landfill gas venting system

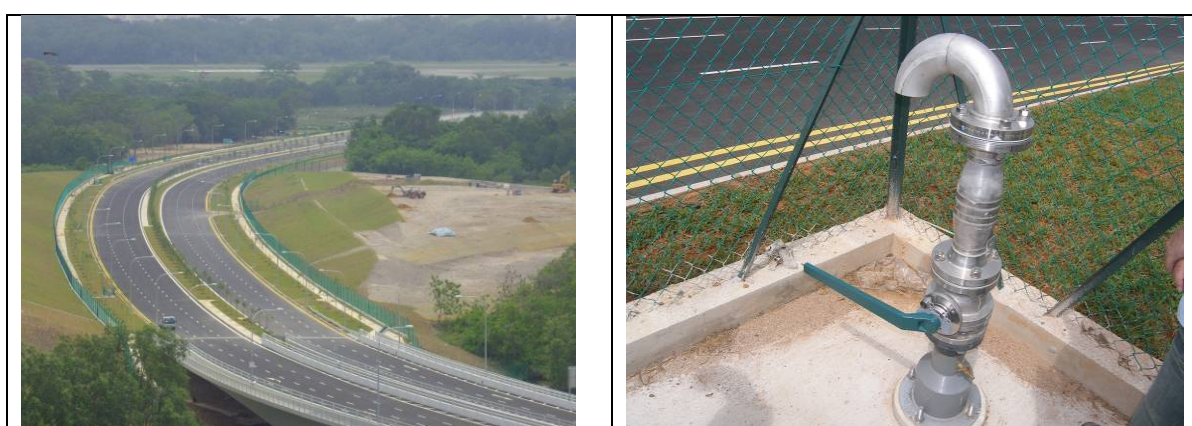
Figure 10 Overview of completed new road at landfill site. Close up view shows gas venting outlet with control valve and flame arrestor in fenced enclosure at the road sidetable.
